**Report
to the Chairman of the Hungarian Atomic
Energy Commission**

**on the Authority's investigation of the incident
at Paks Nuclear Power Plant on 10 April 2003**

(Identification number of the event: 1120)

Hungarian Atomic Energy Authority

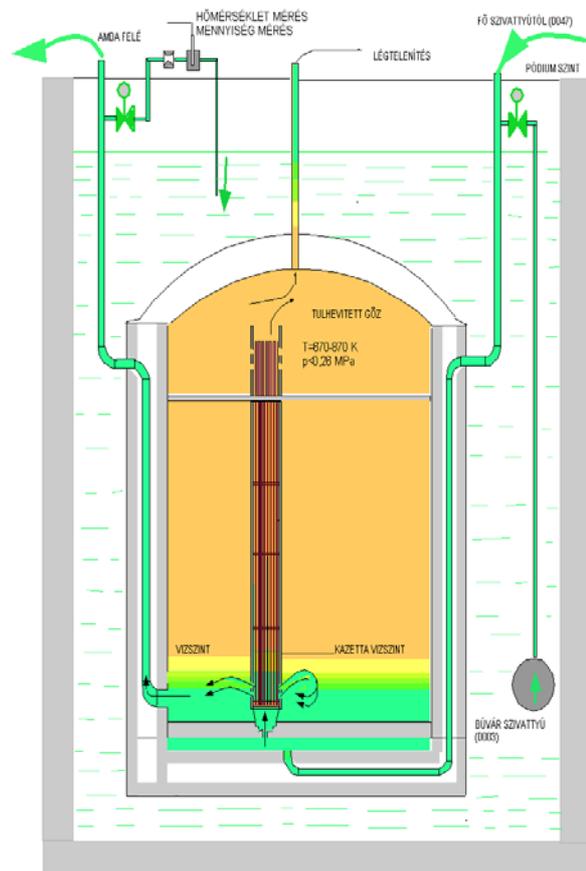
In the course of the refinement of the model an effect was revealed as a result of which the flow of the cooling water along the assemblies gradually decreased, while a by-passing flow through the small bore-holes of the assembly superficies proportionately increased. It is obvious that a decrease in the cooling water flow is coupled to an increase in the temperature. The speed of this redistribution process depends on the remanent heat production of the assemblies, on the capacities of the pump and on the number of bore-holes.

Scheme of the cleaning vessel at the phase of overheating (figure not in scale, and only one assembly shown).

In summary, judging from a reconstruction of the events, with the given capacity of the pump and the geometry of the vessel such an increasing by-pass flow developed through the bore-holes located on the assembly walls that the remanent heat caused the fuel assemblies to overheat.
